Project Name: **424-426 W First Street**
Date of Review: **5/6/2021 04:39:51 PM**
Project Category: **Development, Other**
Project Area: **0.16 acres**
County(s): **Blair**
Township/Municipality(s): **WILLIAMSBURG**
ZIP Code:
Quadrangle Name(s): **WILLIAMSBURG**
Watersheds HUC 8: **Upper Juniata**
Watersheds HUC 12: **Frankstown Branch Juniata River-Juniata River**
Decimal Degrees: **40.462887, -78.201786**
Degrees Minutes Seconds: **40° 27' 46.3943" N, 78° 12' 6.4297" W**

Careful demolition of Unit #424 in combination with the addition of some supplementary structure and Unit #426 will be shored up and receive rehabilitation to address code deficiencies in compliance with adopted Housing Rehabilitation standards

- I. INTRODUCTION
- II. SURVEY SUMMARY
- III. ASBESTOS OVERVIEW
- IV. LIMITATIONS
- V. ANALYTICAL RESULTS
- VI. ASBESTOS RECOMMENDATIONS
- VII. SITE PLAN
- VIII. SITE PHOTOGRAPHS
- IX. GLOSSARY
- X. LICENSING
- XI. LABORATORY REPORT

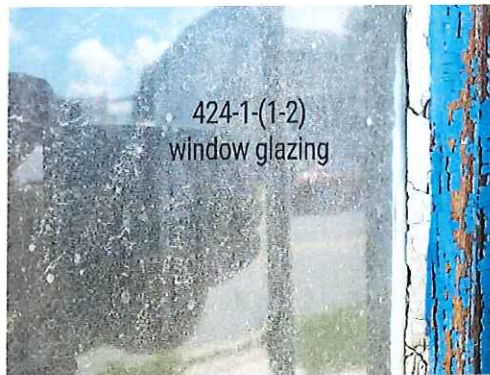
424-1-(1-2)
window glazing

424-1
Window glazing
Typical exterior windows

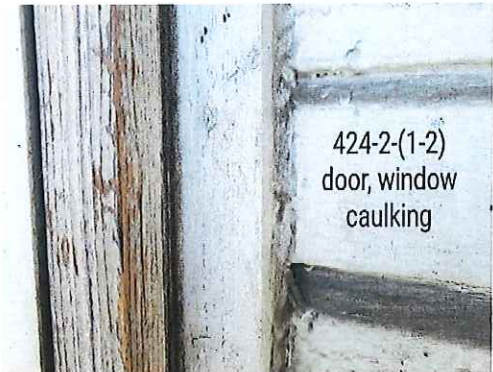
424-2-(1-2)
door, window
caulking

424-2
Door, window caulk
Typical exterior doors, windows

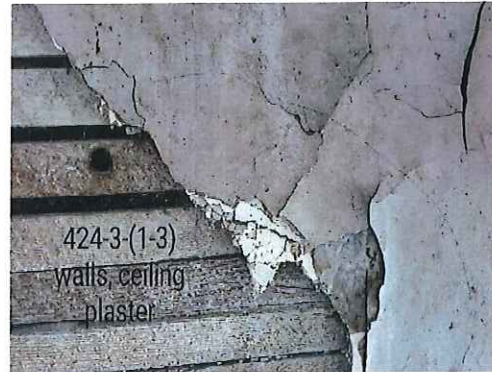
424-3-(1-3)
walls, ceiling
plaster

424-3
Wall, ceiling plaster
Typical interior walls, ceilings

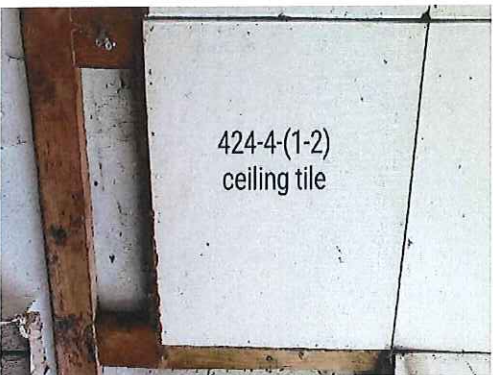
424-4-(1-2)
ceiling tile

424-4
12"x12" ceiling tile
Interior Bathroom

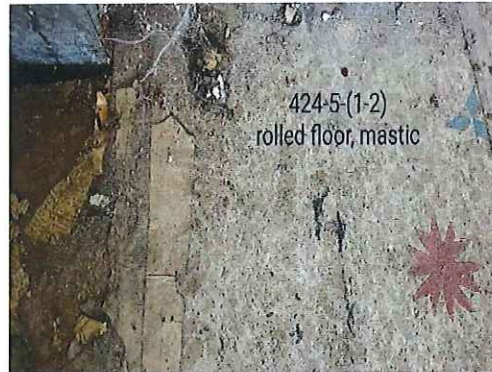
424-5-(1-2)
rolled floor, mastic

424-5
Rolled flooring/mastic
Interior Living Room

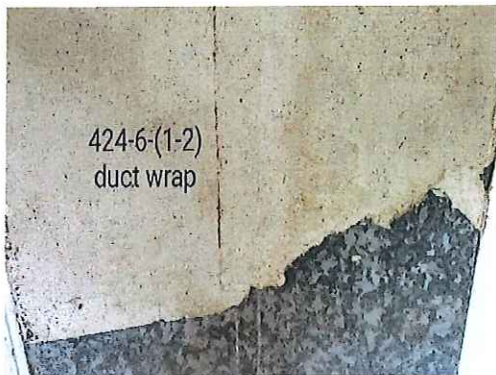
<i>Sample Number</i>	<i>Description</i>	<i>Condition</i>	<i>Friable</i>	<i>Asbestos Percent and Type</i>	<i>Location/ Amount</i>	<i>NESHAP Category</i>
424-5-2	Mastic	Intact	No	None Detected	Interior Living Room	NA
424-6-1	Duct Wrap	Deteriorated	Yes	30% Chrysotile	Typical Interior	RACM
424-6-2	Duct Wrap	Deteriorated	Yes	Not Analyzed Positive Stop	Typical Interior	RACM
424-7-1	Insulation	Intact	No	None Detected	Typical Interior	NA
424-7-2	Insulation	Intact	No	None Detected	Typical Interior	NA

424-6
Duct wrap
Typical interior
30% Chrysotile

The EPA and NESHAP recommend that a point-counting procedure be utilized for confirmation of asbestos percentage in friable materials that are visually estimated by PLM methodology to contain less than 10% asbestos. The 400 Point Count Procedure referenced in EPA 600/M4-82-020 (1987) and EPA 600/R-93/116 (1993) is commonly employed. Without the material being point counted or if point counting determined that material contains greater than one percent asbestos, it would be deemed an asbestos containing material and would need to be removed by a Pennsylvania licensed asbestos contractor prior to disturbance.

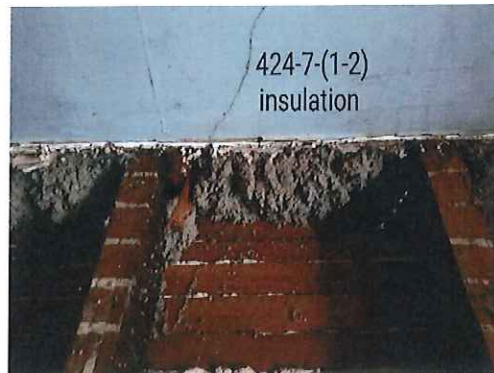
424-7
Insulation
Typical interior
